Management and Maintenance Manual  
The Old Hospital Complex  
Fort Carson, Colorado  
(5EP1778)

James Schneck

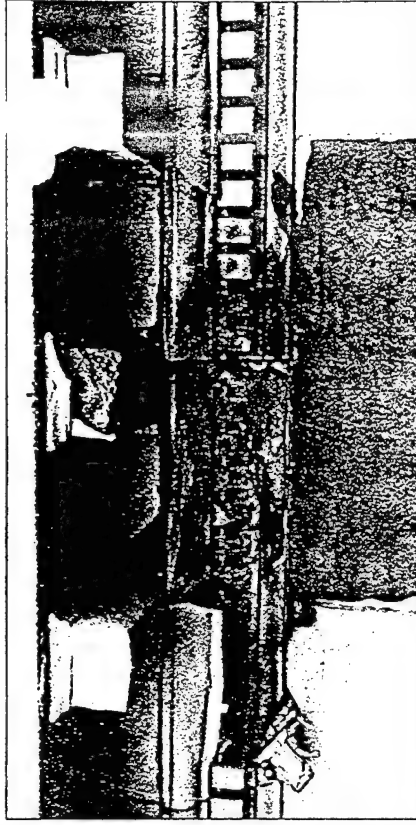
*Moisture from a faulty roof and drainage system has been trapped inside this limestone cornice by a waterproof coating, causing severe damage to the stone.*

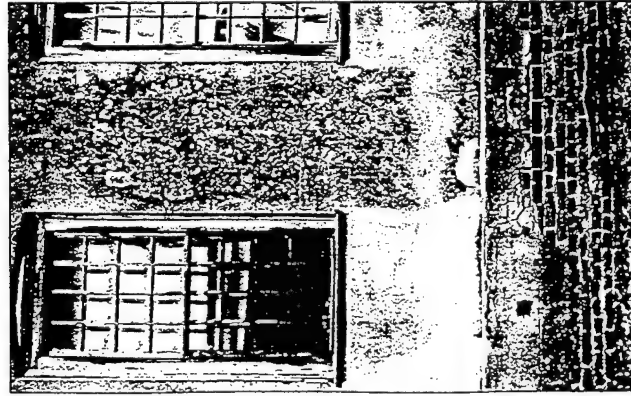
Photo: Jack E. Boucher, HAB5

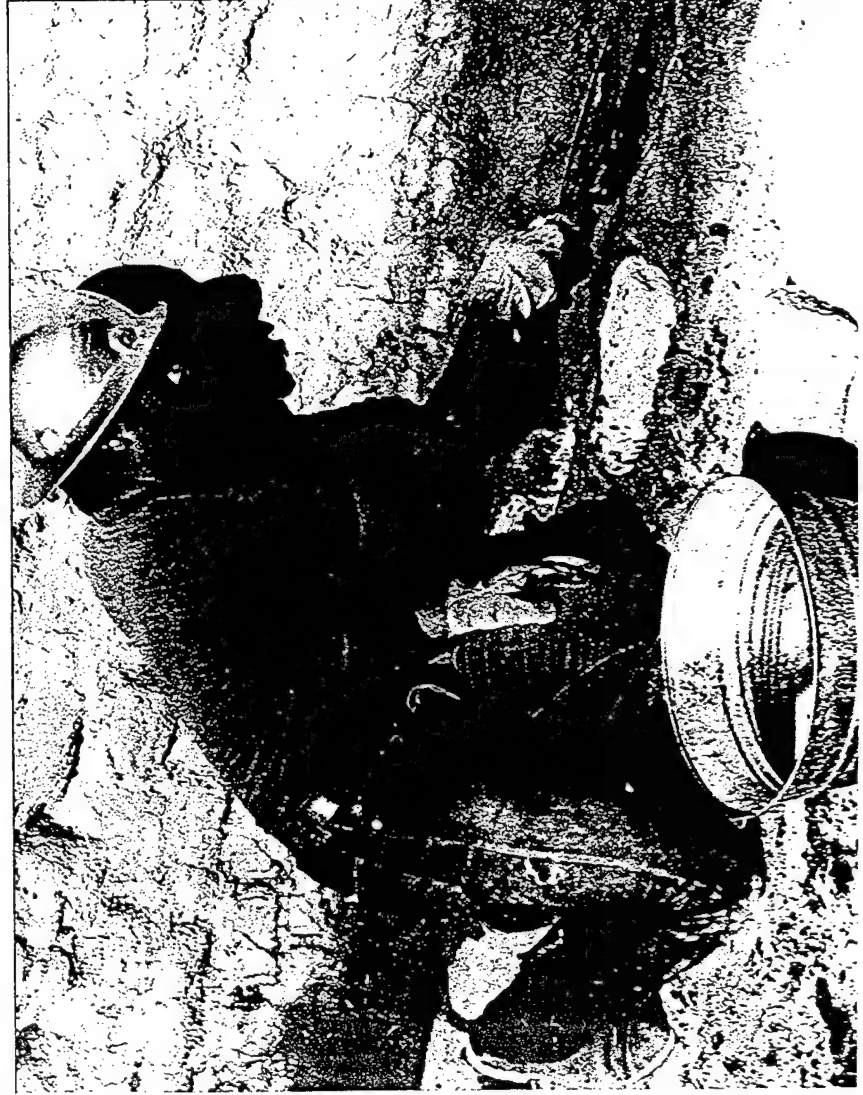
*Coving—the hollowing out of an adobe wall just above grade—may be caused by standing rainwater, rainwater splash-up from the ground, or by salts deposited in the adobe by moisture evaporation. This adobe wall is being patched in the traditional manner with adobe mud.*

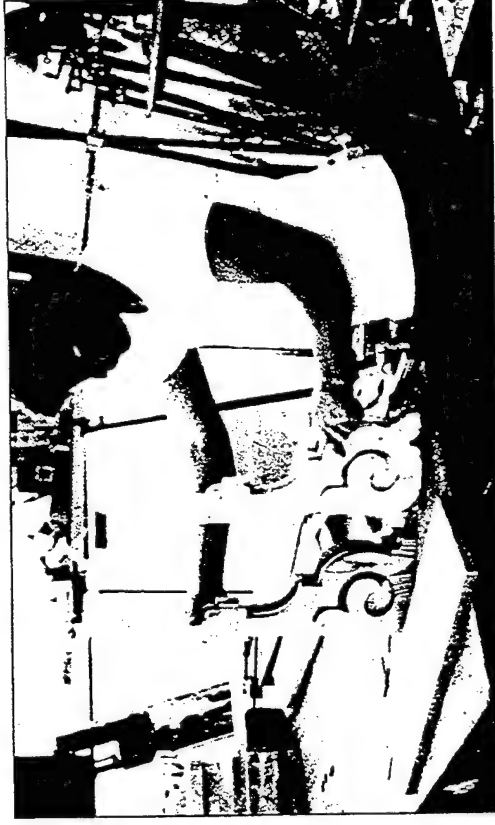
Removing damaged or deteriorated paint to the next sound layer using the gentlest method possible (handscraping and handsanding), then repainting.

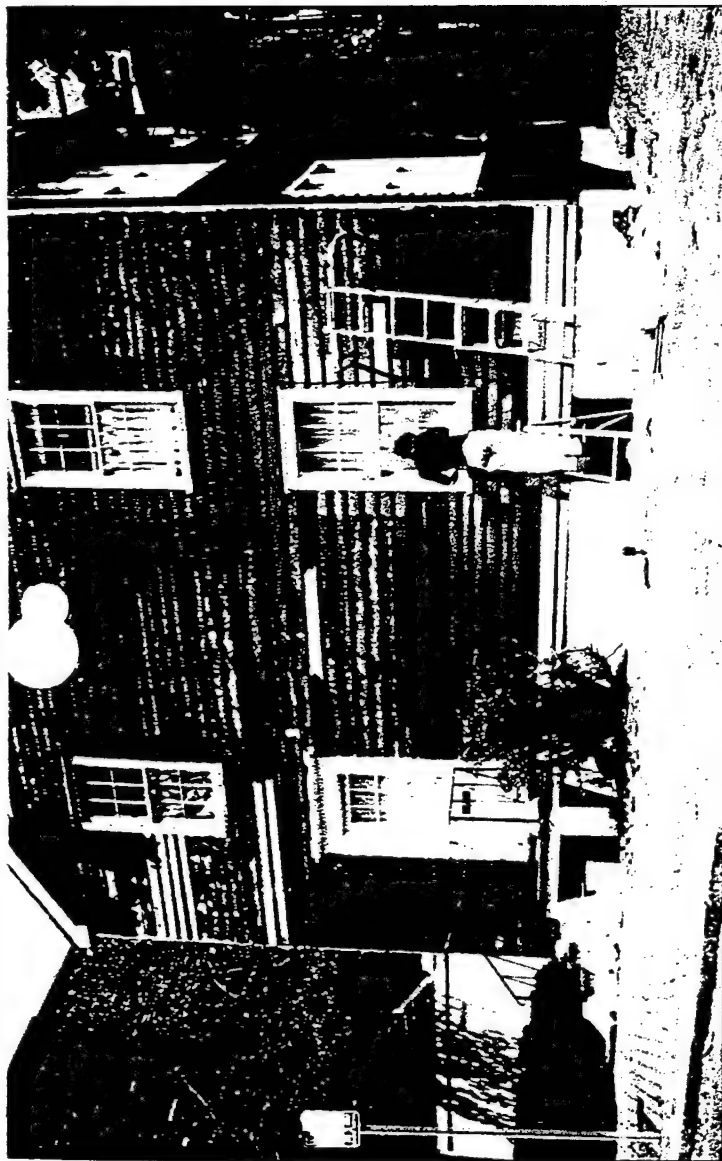
*Deteriorated clapboards are being selectively replaced, thereby maximizing retention of the historic siding.*

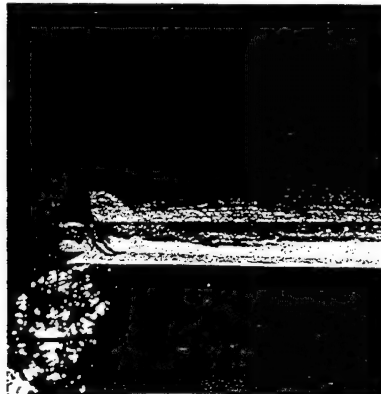
*To replace deteriorated portions of the column, strips of new wood were milled to conform to the shape and appearance of the old column framework, glued in place, then back-primed and painted.*

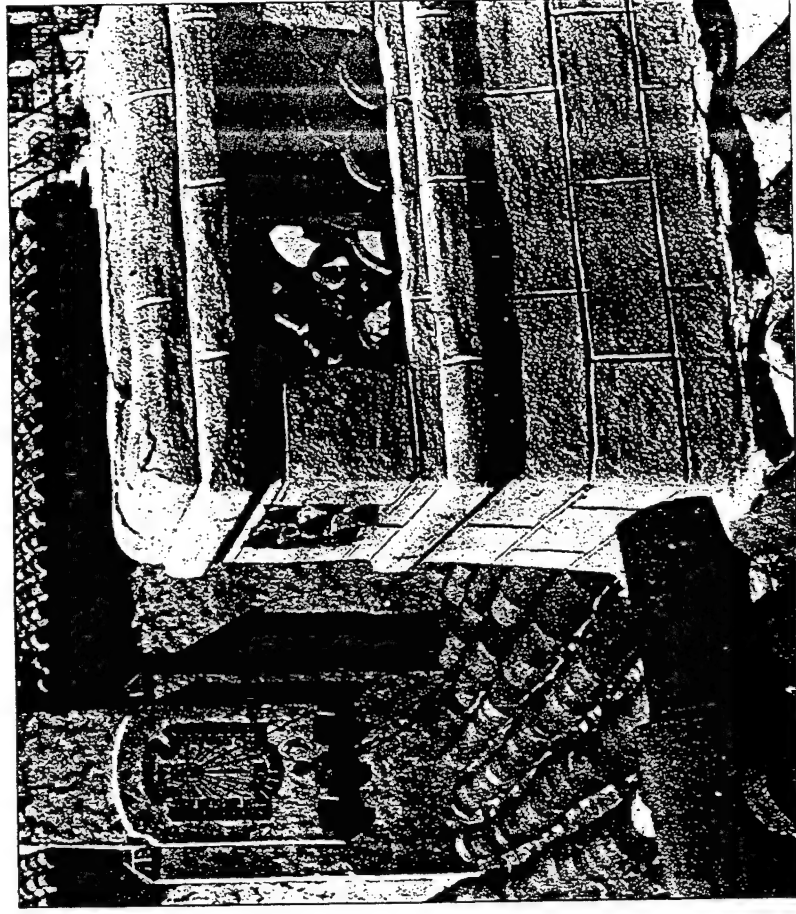
of slate for roofing dates from the mid-17th century. Slate has remained popular for its durability, fireproof qualities, and decorative applications. The use of metals for roofing and roof features dates from the 18th century, and includes the use of sheet iron, corrugated iron, galvanized metal, tinplate, copper, lead and zinc. Awareness of these and other traditions of roofing materials and their detailing will contribute to more sensitive treatment.

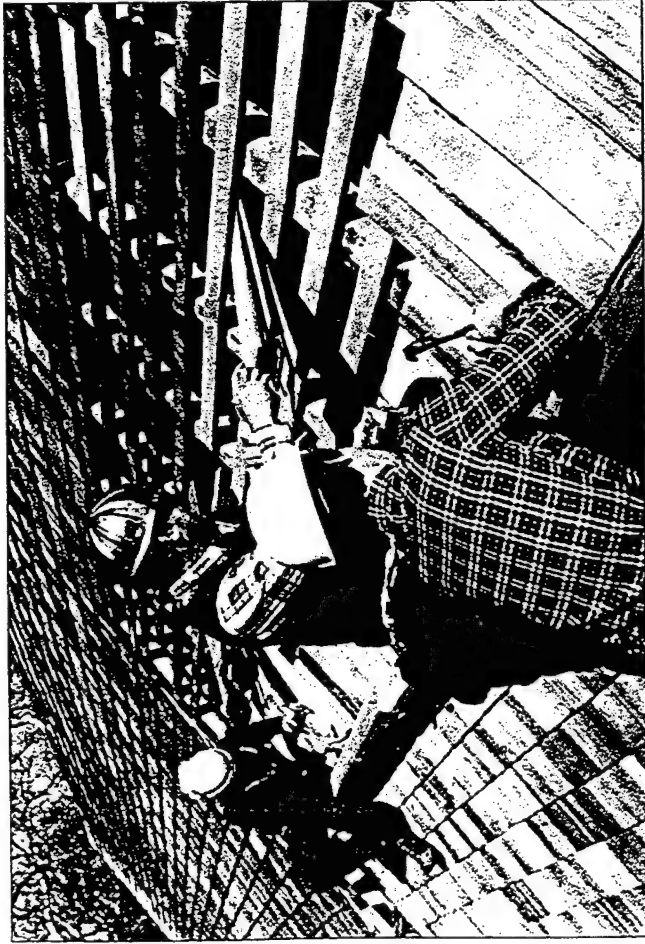
*The size, shape, and detailing of the historic shingles as well as the method of fabrication and installation were carefully researched prior to selecting this new wood-shingle roofing.*

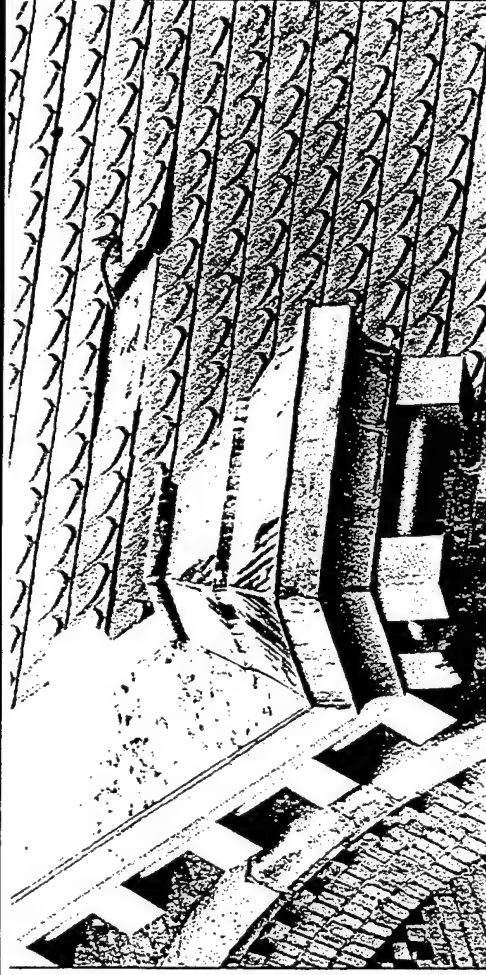
*The following work is highlighted to indicate that it represents the particularly complex technical or design aspects of rehabilitation projects and should only be considered after the preservation concerns listed above have been addressed.*

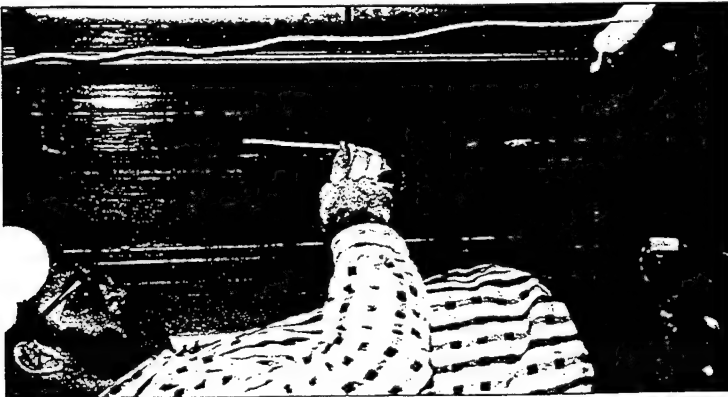
Maintaining a historic window may include work as basic as replacing a sash cord.

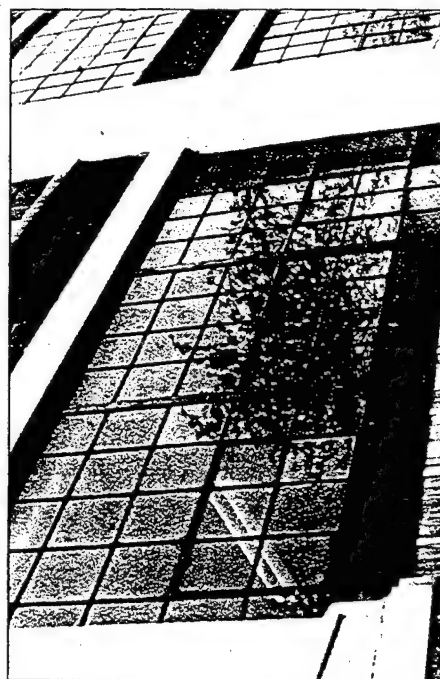
*The steel pivot windows in this historic manufacturing building were replaced with new windows which matched the multi-lighted originals.*

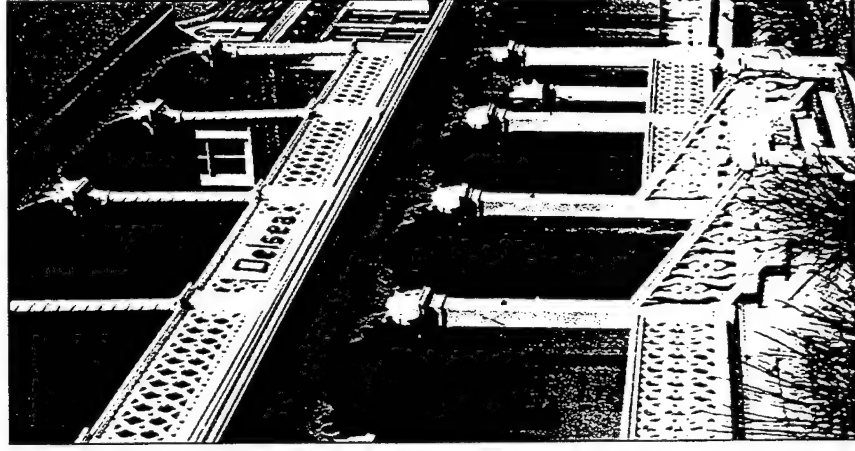
ments. Porches were particularly prominent features of Eastlake and Stick Style houses; porch posts, railings, and balusters were characterized by a massive and robust quality, with members turned on a lathe. Porches of bungalows of the early 20th century were characterized by tapered porch posts, exposed post and beams, and low pitched roofs with wide overhangs. Art Deco commercial buildings were entered through stylized glass and stainless steel doors.

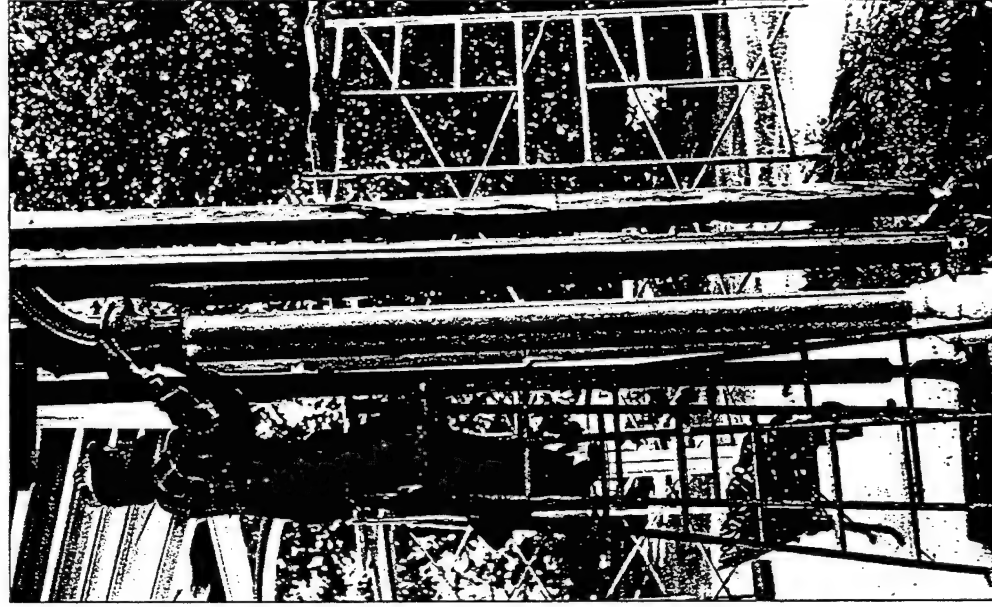
*Careful inspection of porch features such as these column capitals is necessary before initiating a rehabilitation project.*

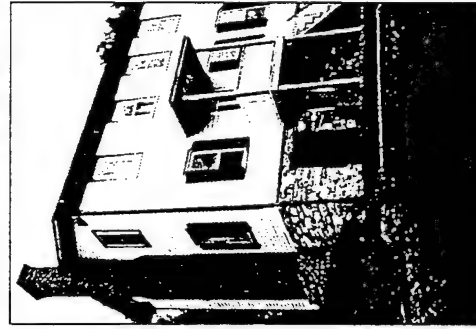
#### Not Recommended

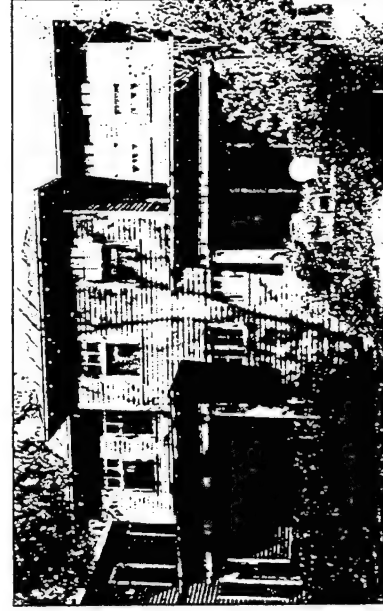
#### Not Recommended

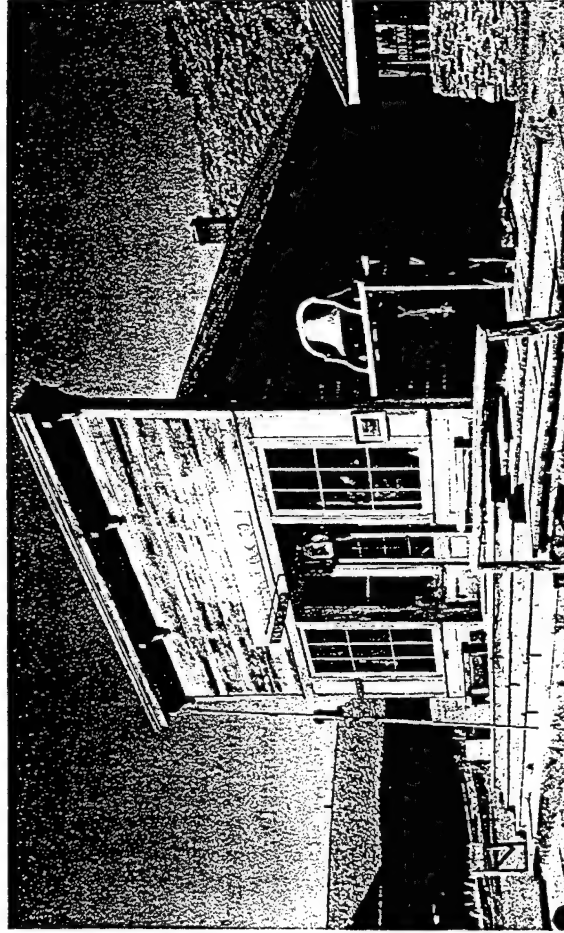
Photo: Jack E. Boucher, HABS.

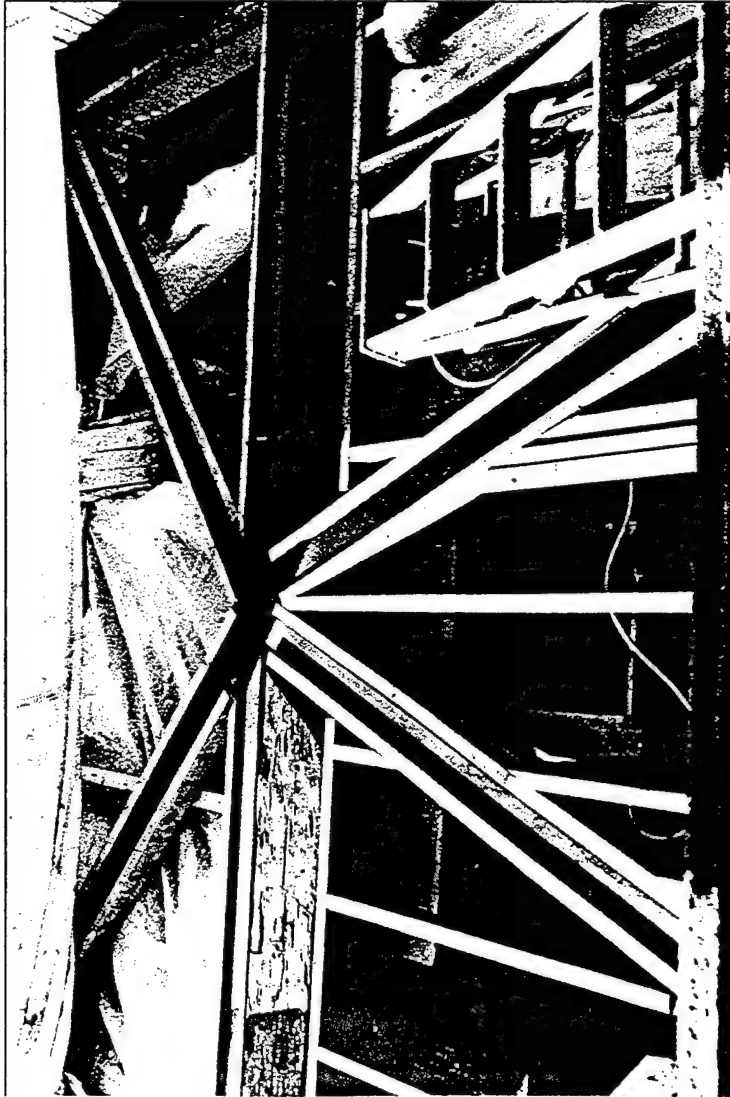
Photo: Irving B. Haynes and Associates

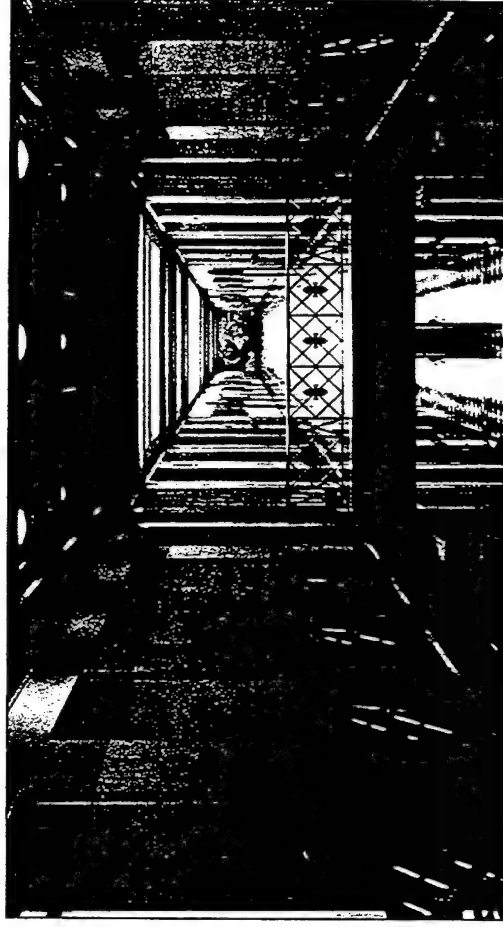
Secondary spaces include areas and rooms that “service” the primary spaces and may include kitchens, bathrooms, mail rooms, utility spaces, hallways, fire stairs and work spaces in a commercial or office building. Extensive changes can often be made in these less important areas without having a detrimental effect on the overall historic character.

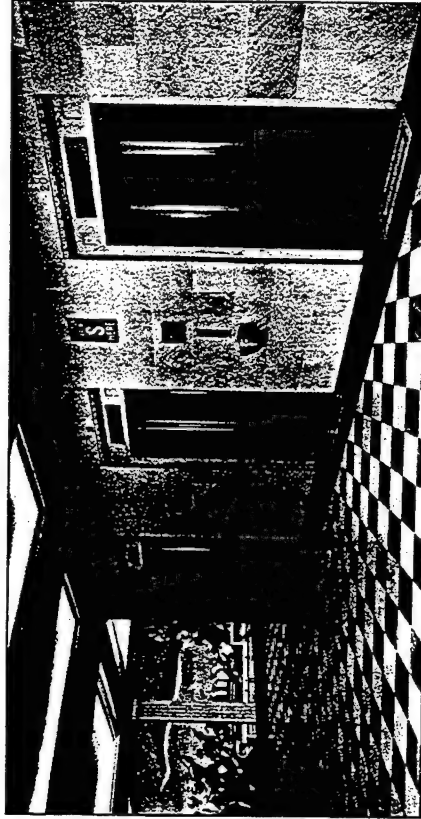
*The bronze elevator doors and light coffers play an important decorative role in this early-20th century administrative building.*

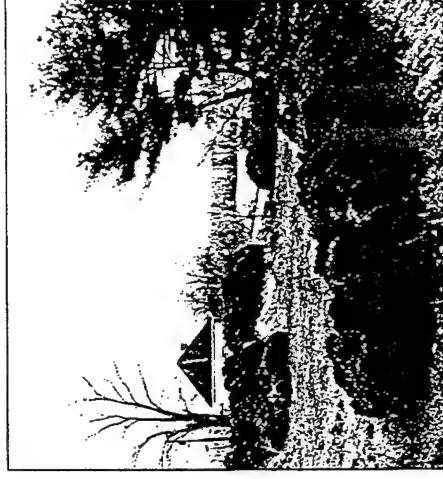
plants, creates an appearance that is constantly changing, both seasonally and annually. Since most plant material is adapted to specific environments, the character of landscapes varies dramatically in different climates, elevations and regions.

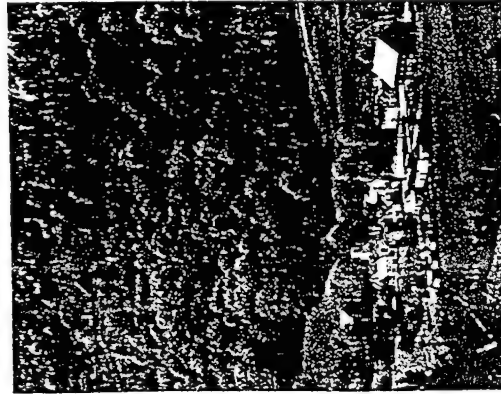
*The setting is an important aspect of a historic district. In a rural historic district, the natural topography and landscape features, agricultural field patterns, roads, and the organization of buildings and structures all contribute to its character.*

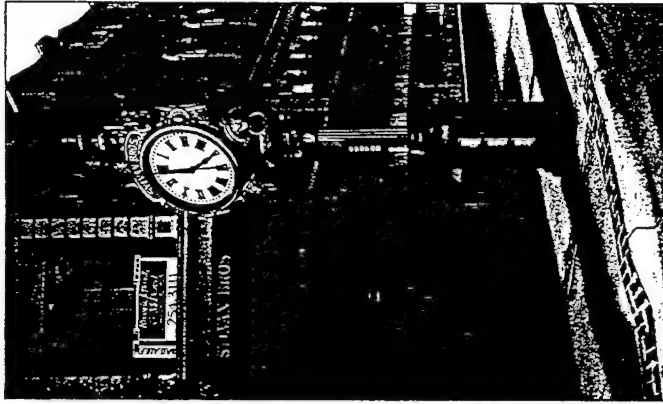
Photo: Jack E. Boucher, HABS.

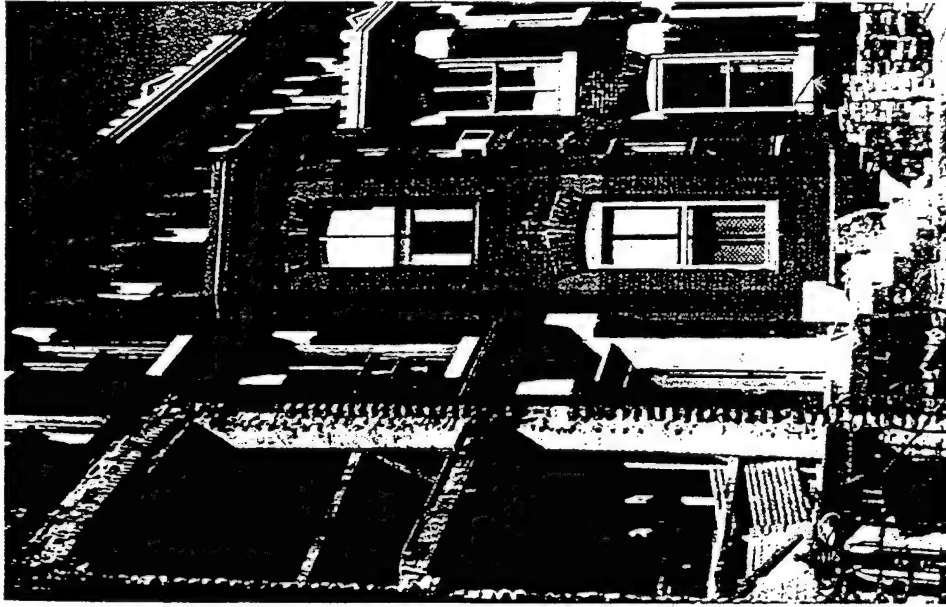
*This late-19th century residential historic district is characterized by brick row-houses with two-storied bays. A street-scene's visual continuity can be marred by an insensitive rehabilitation such as the one shown here. The original two-story brick bay of one of the houses was removed and replaced with a three-story bay that is incompatible in size, materials, and detailing.*

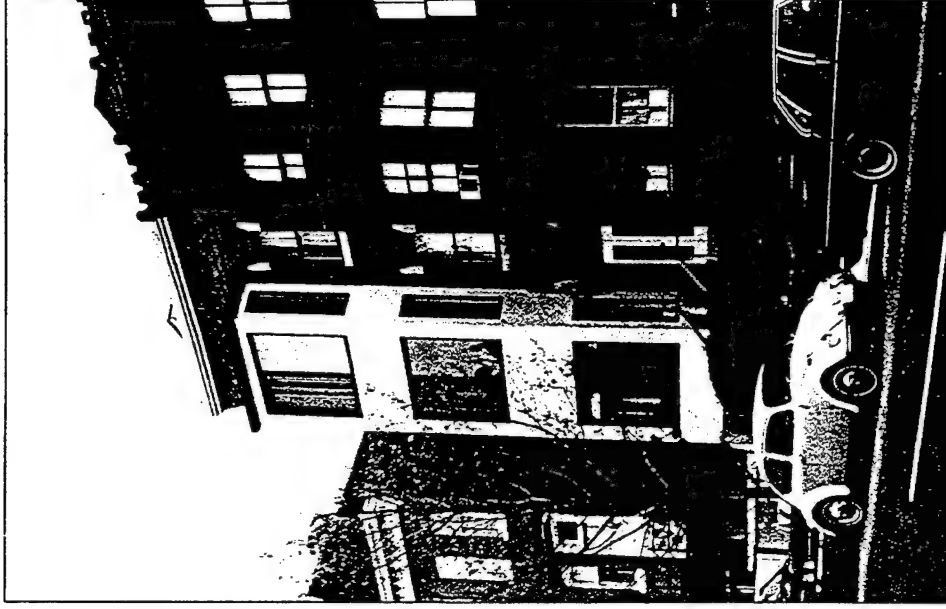
Replacing in kind an entire feature of the building or landscape that is too deteriorated to repair — when the overall form and detailing are still evident — using the physical evidence as a model to guide the new work. If using the same kind of material is not technically or economically feasible, then a compatible substitute material may be considered.

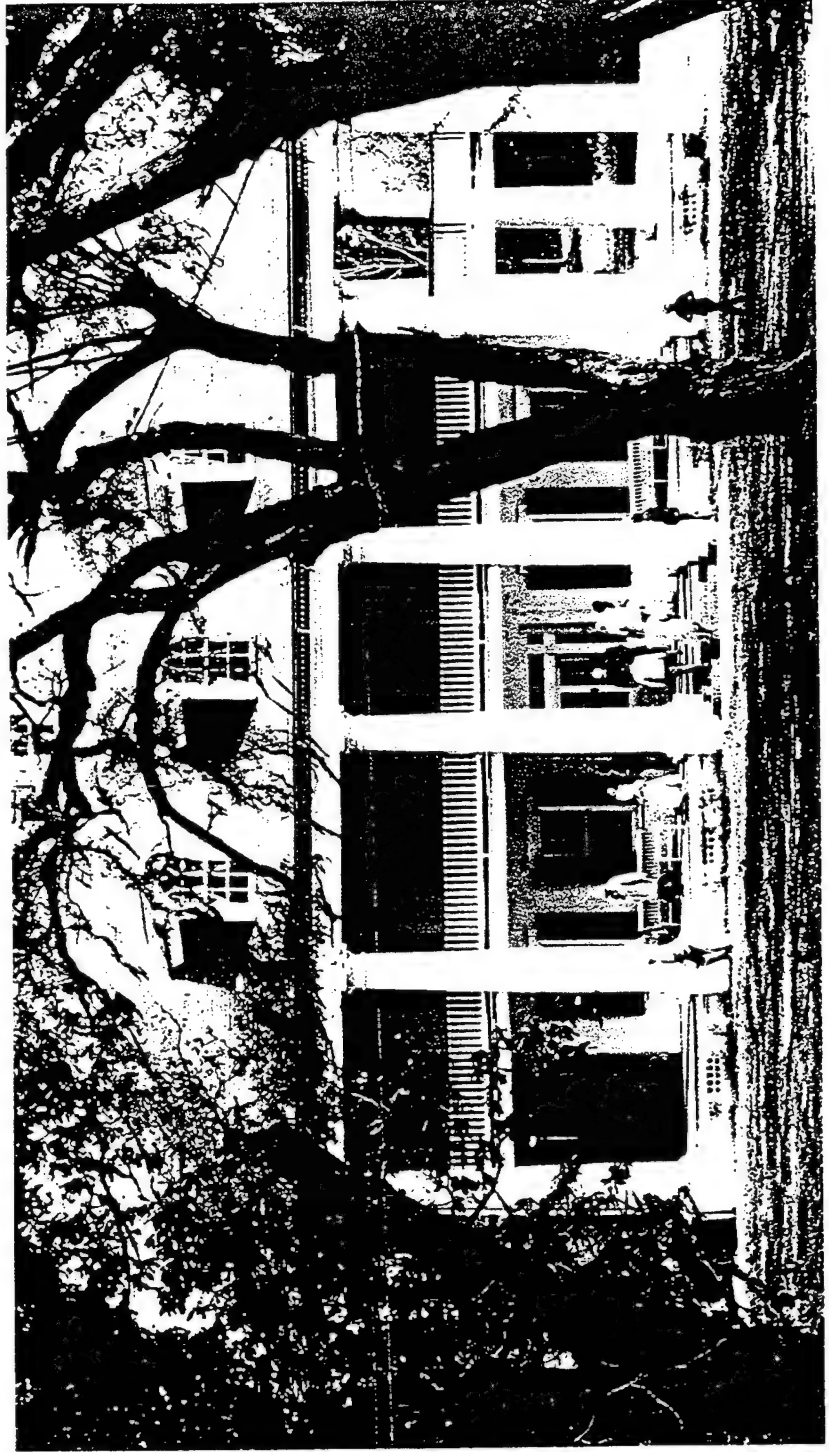
*In hot climates, buildings were historically designed to minimize the heat gain from the summer sun. The wide roof overhangs, exterior porches, shutters, shade trees, and heavy masonry walls (painted white) are all energy saving characteristics.*

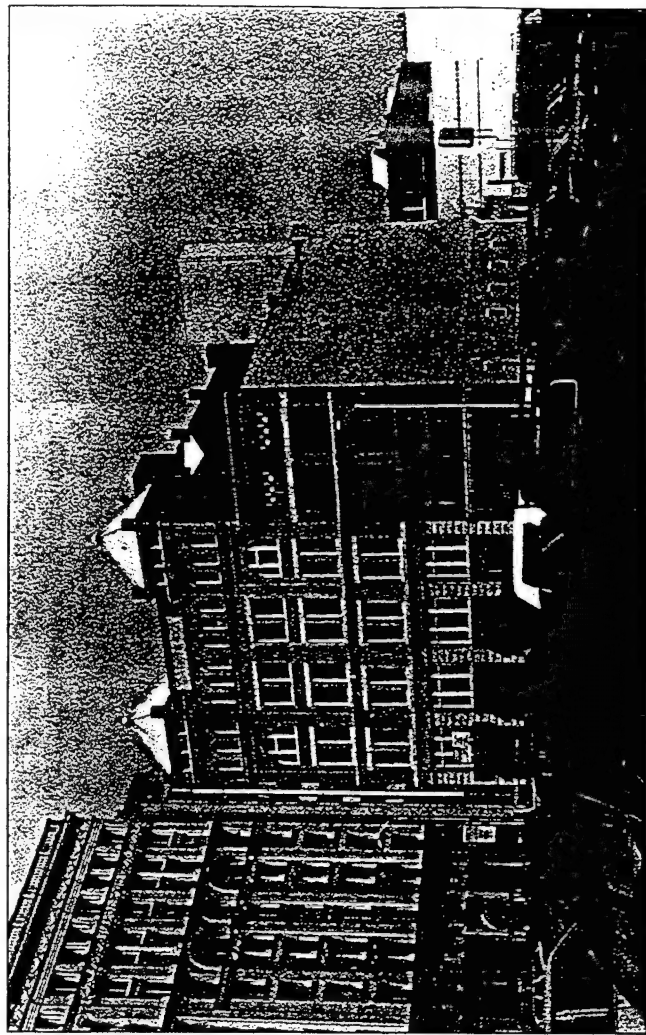
*Left: This roof addition has substantially altered the historic profile and proportions of a three-story row house; more important, it has interrupted the uniform roof height of the block. The greenhouse is also a jarring element in an otherwise intact 19th century streetscape. Below: A sizeable employee lounge was added atop this four-story historic commercial building. Because the rooftop addition has been set back from both the front and side roof edges against a party wall, the historic character of the building and the district have been preserved.*

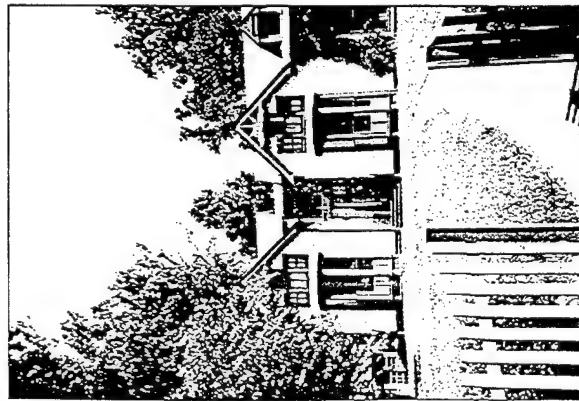
*The historic residence is on the right. By copying the decorative gable and three-part window in the new addition, the old and new portions are virtually indistinguishable. This approach violates the Standards for Rehabilitation.*

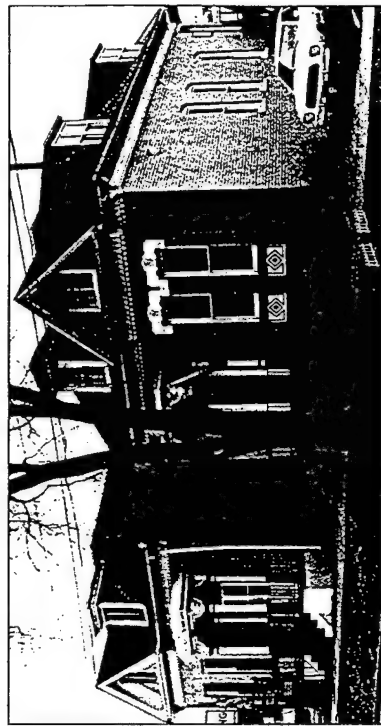
*In rehabilitating a historic bank for a new use, a small restaurant addition was built on the rear. The new addition is compatible with the historic building primarily because of its scale and location.*

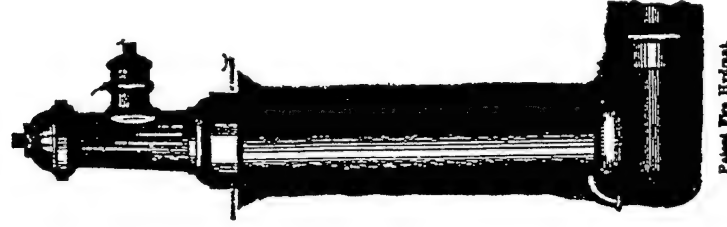
**X-Ray Examination of Historic Structures.** David M. Hart. Explains a method for nondestructive probing of historic buildings that permits investigation of components normally hidden from view. Intended for architects, conservators, and other professionals. 24 pages. 19 illustrations. Bibliography. 1975.

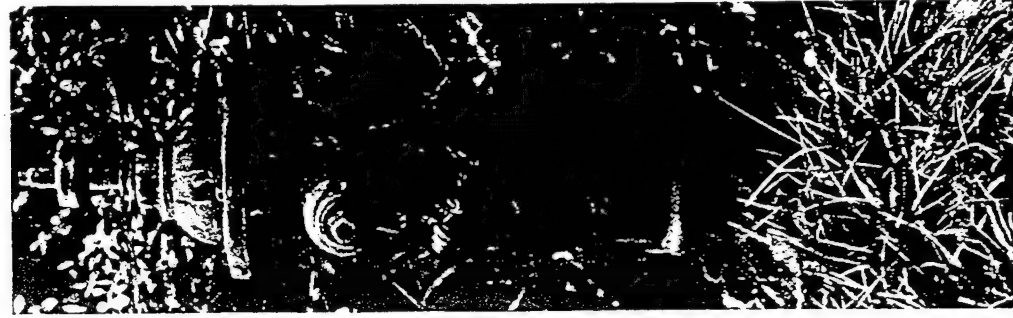
PTN 36 Windows(19): Aluminum Replacement With True Divided Lights, Interior Piggyback Storms, and Exposed Historic Wooden Frames by Charles Parrott. October, 1991.

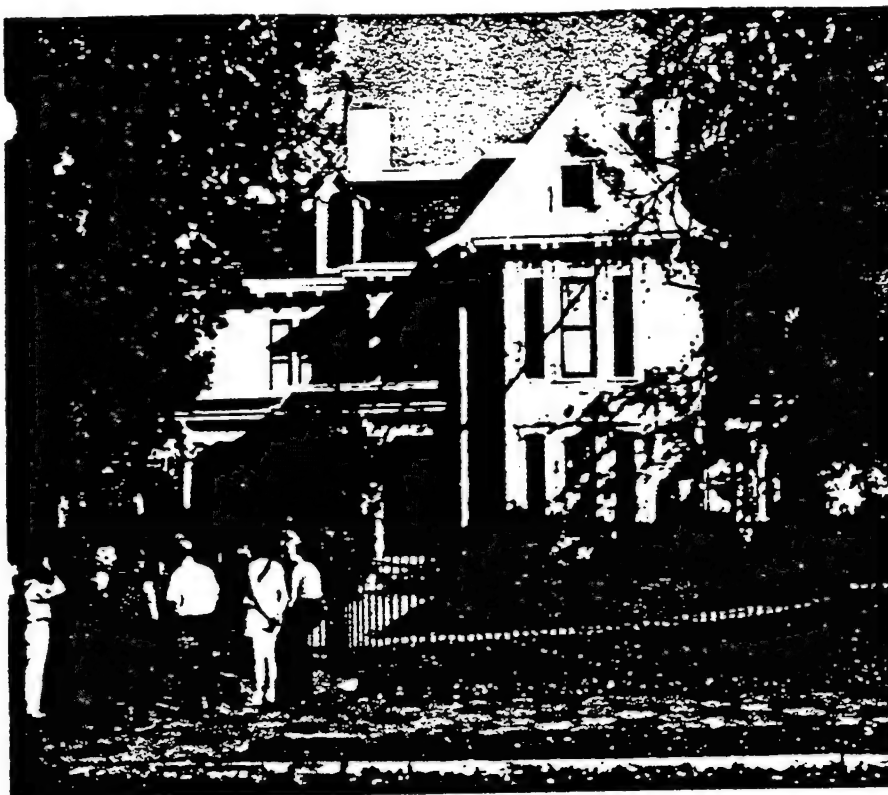
## TRUMAN HOME HARRY S TRUMAN NATIONAL HISTORIC SITE Independence, Missouri

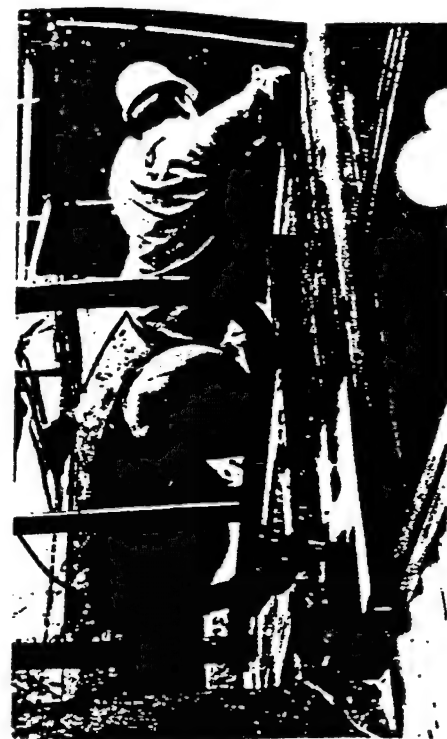
Figure 5. Using scaffolding, workers remove the paint with heat guns. Cracked or deteriorated siding was repaired or replaced. Photo: Alan O'Bright

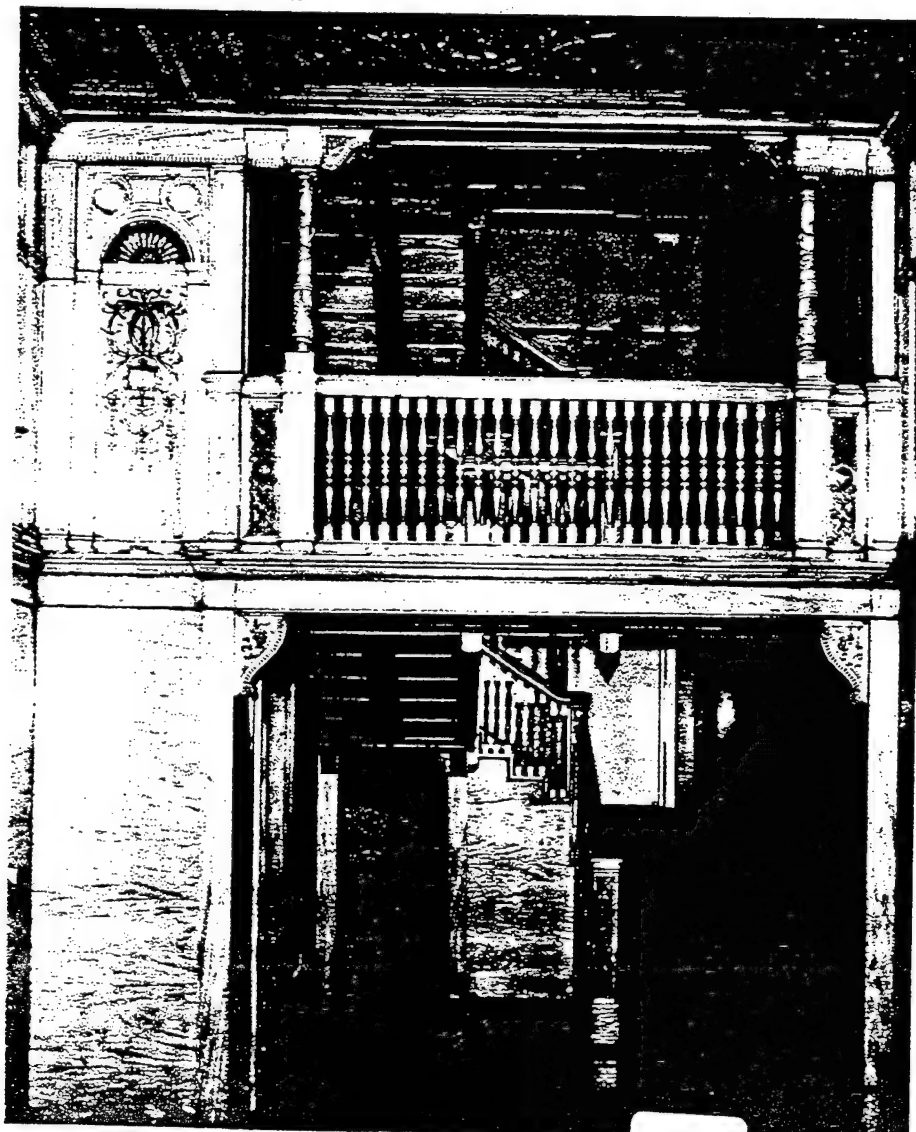
Figure 2. A system for protecting the decorative staircases was drawn and specified by the project architect. Drawing: Christina Henry.

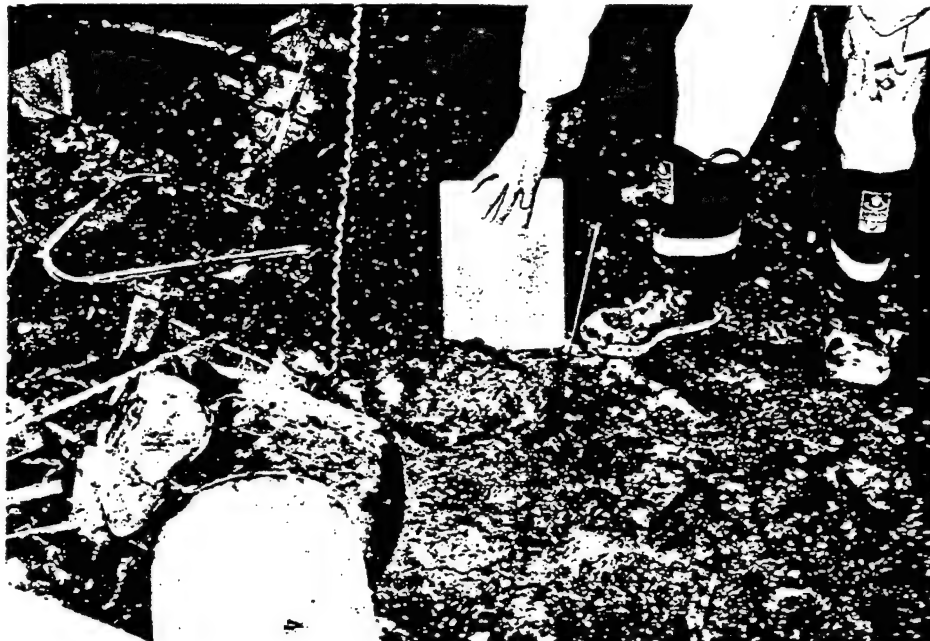
Figure 1. The spontaneous combustion of cloth rags that had been used in applying a common finishing wax caused over \$1 million damage to a historic government office building in 1991. Remains of the trash can where the rags had been stored overnight is indicated by the fireman's notepad. After the cause of the fire was determined, a standard specification provision was developed for future contracts requiring the contractor to remove all material contaminated with finishing products from the site at the end of the day.

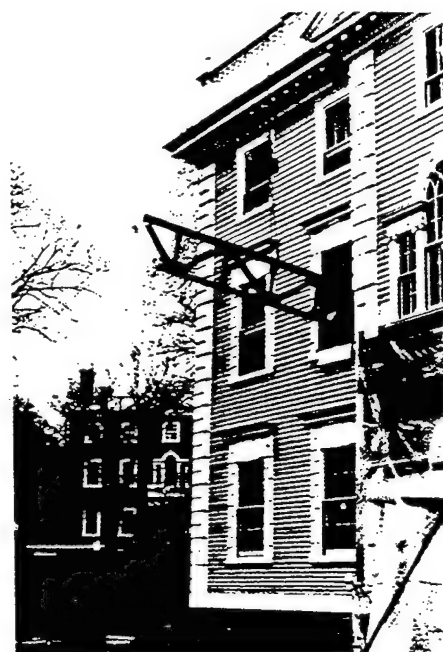
Figure 2. Because of the fire risks, open flame cutting and welding deserves careful attention both in the preparation of specifications and during the work. As much welding as possible should be done off site. For example, at the Nightingale-Brown House, several large trusses were assembled off site, then carefully hoisted through a window for installation. Photo: Irving B. Haynes and Associates.

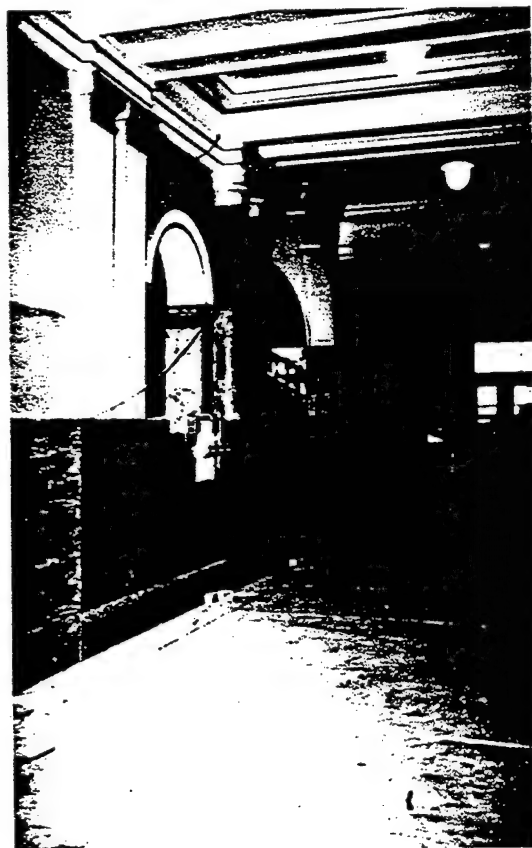
Figure 5. To provide for adequate floor protection in the New Jersey State Capitol, this area was swept clean, then covered with polyethylene sheeting to protect against spills and dirt abrasion. Fiberboard (1/2" thick) was placed over floors and the joints sealed with tape. Finally 1/2" plywood was laid with all joints taped. This floor protection system has been successful over many years of use and is recommended in major construction areas, and where tile, marble, parquet wood, or other historic flooring is involved. Photo and drawing: Ford Farewell Mills and Gatsch Architects.

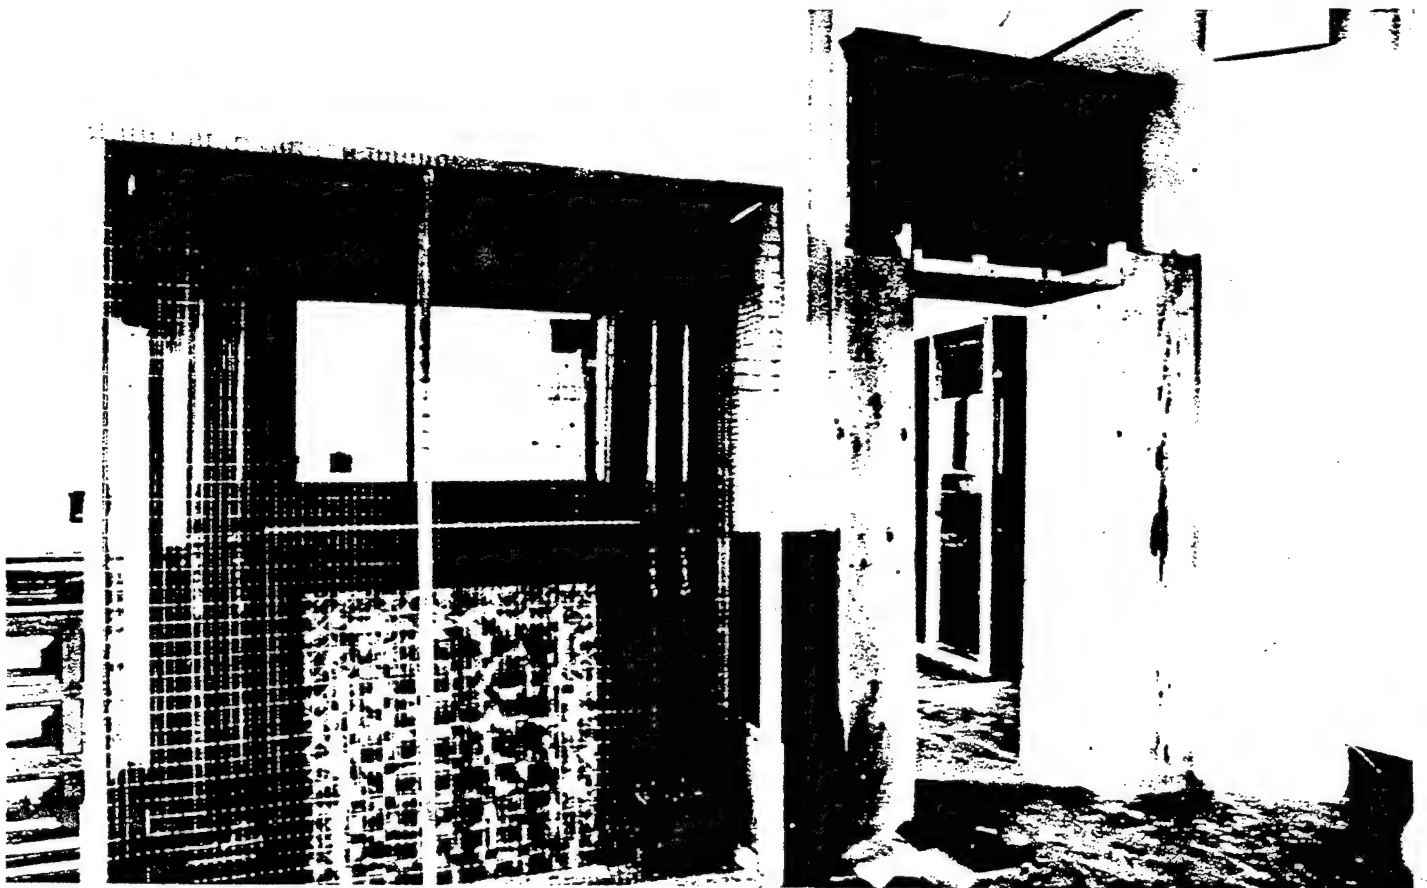
Figure 6. A self-supporting impact cage utilizing wood and wire mesh protects the fireplace. In this project, the long construction process required bidders to have visible access to features such as the fireplace. The wire mesh also facilitated monitoring during the lengthy construction. Photo and drawing: Ford Farewell Mills and Gatsch Architects.

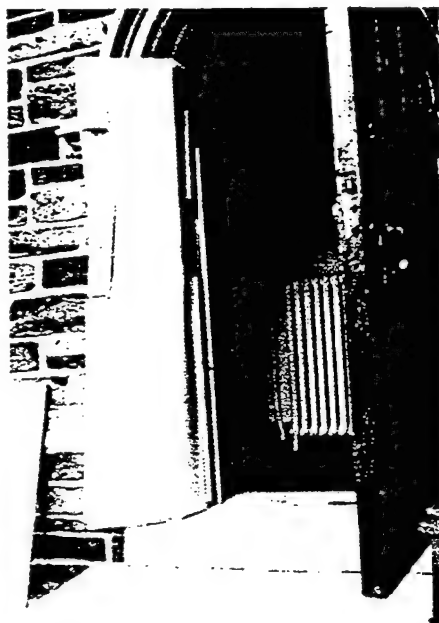
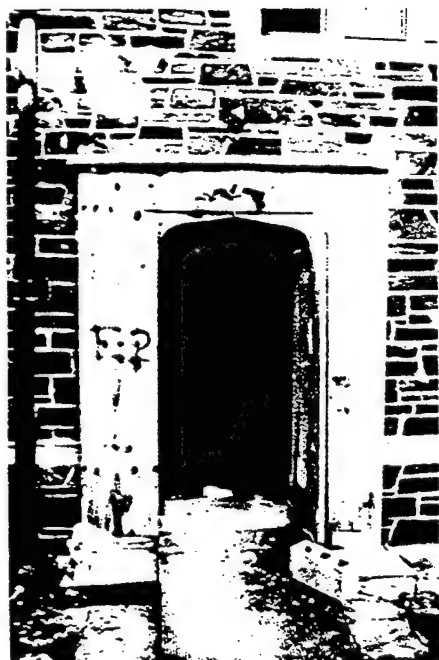
Figure 7. A contractor's solution to protecting the limestone door surround consisted of thin foam sheeting, secured with wood nailed to the masonry. This protection was rejected as inadequate by the architect, and a full plywood enclosure constructed. In the architect's solution, it should be noted that a temporary door is used while the original door is stored for safe keeping during construction. Photo: Ford Farewell Mills and Gatsch Architects.

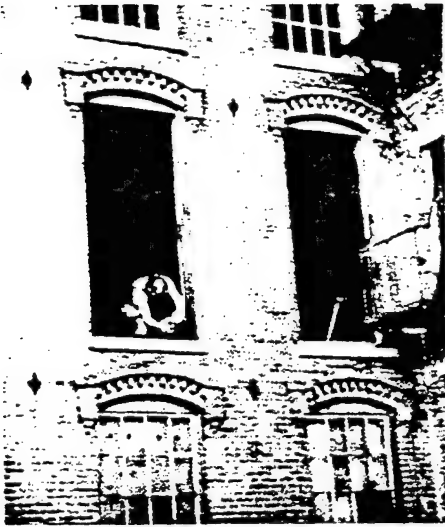
Figure 6. Work on the frames consisted largely of making dutchman repairs to the pulley stiles where required; renailing or replacing brick moldings; replacing some sills; and surface preparation. Photo: Charles Fisher

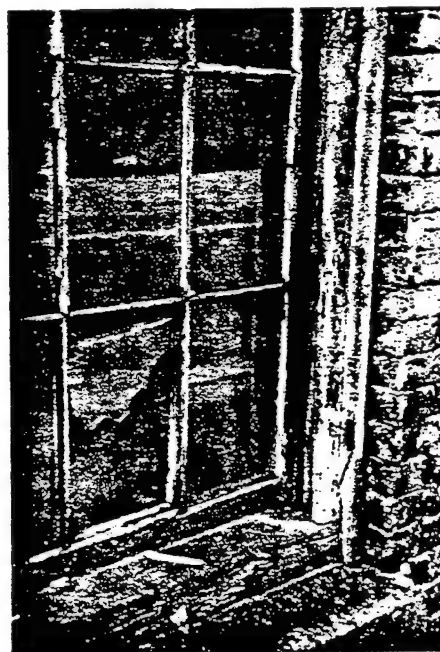
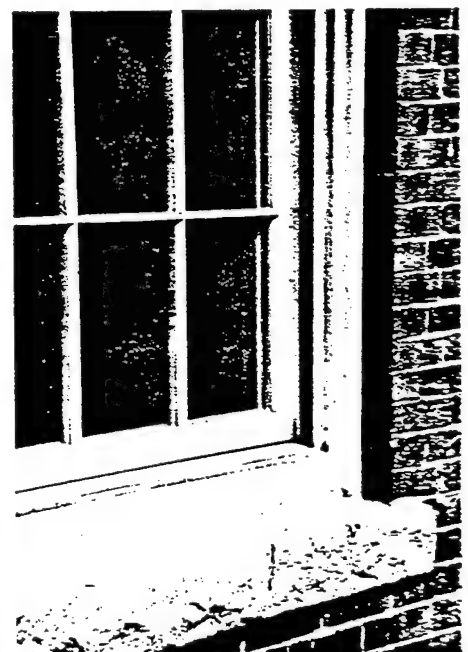
Figure 7. The retention of the exposed outer face of the historic wooden frame and the sill detailing were important qualities of the window treatment. Before and after photos: Charles Parrott

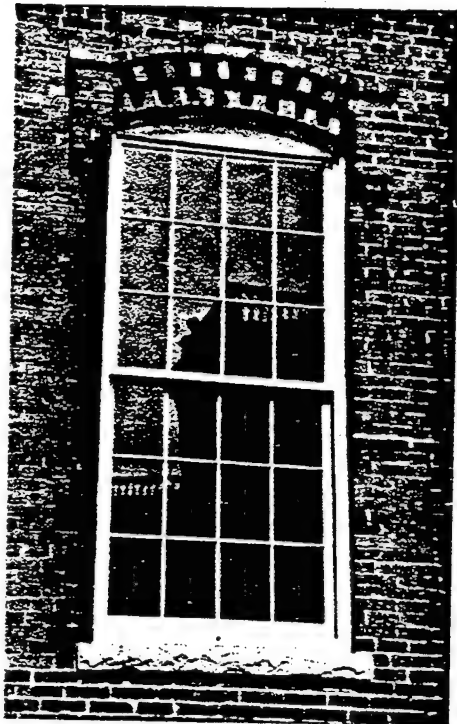
Figure 8. Replacement window sash after installation. Photo: Charles Parrott

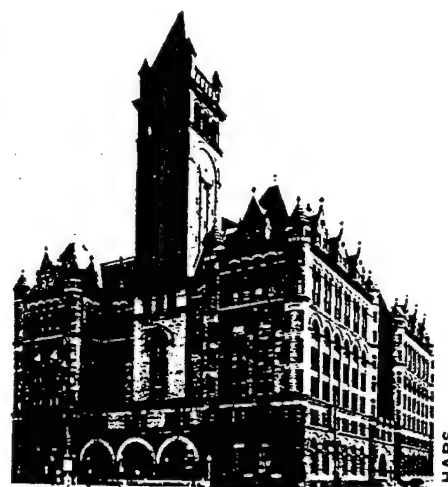
U.S. Department of the Interior National Park Service  
Preservation Assistance Division Technical Preservation Services
